## ENGINE IDLE & FUEL VAPOR IN CESSNA 172R / 172S

### A Historical Compilation of Service Publications

A consolidated reference for Cessna, Lycoming, and FAA service publications addressing fuel vapor, idle mixture, and low power engine operation characteristics in the Cessna 172R and 172S aircraft.

Airworthiness Concern Letter

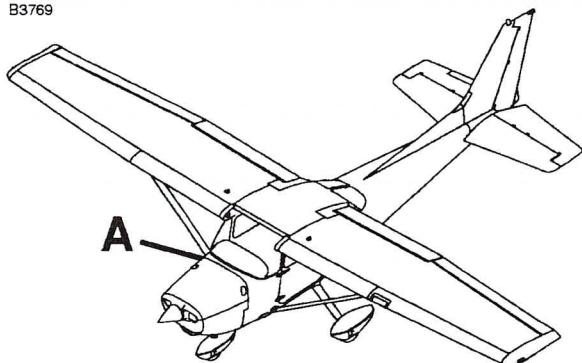
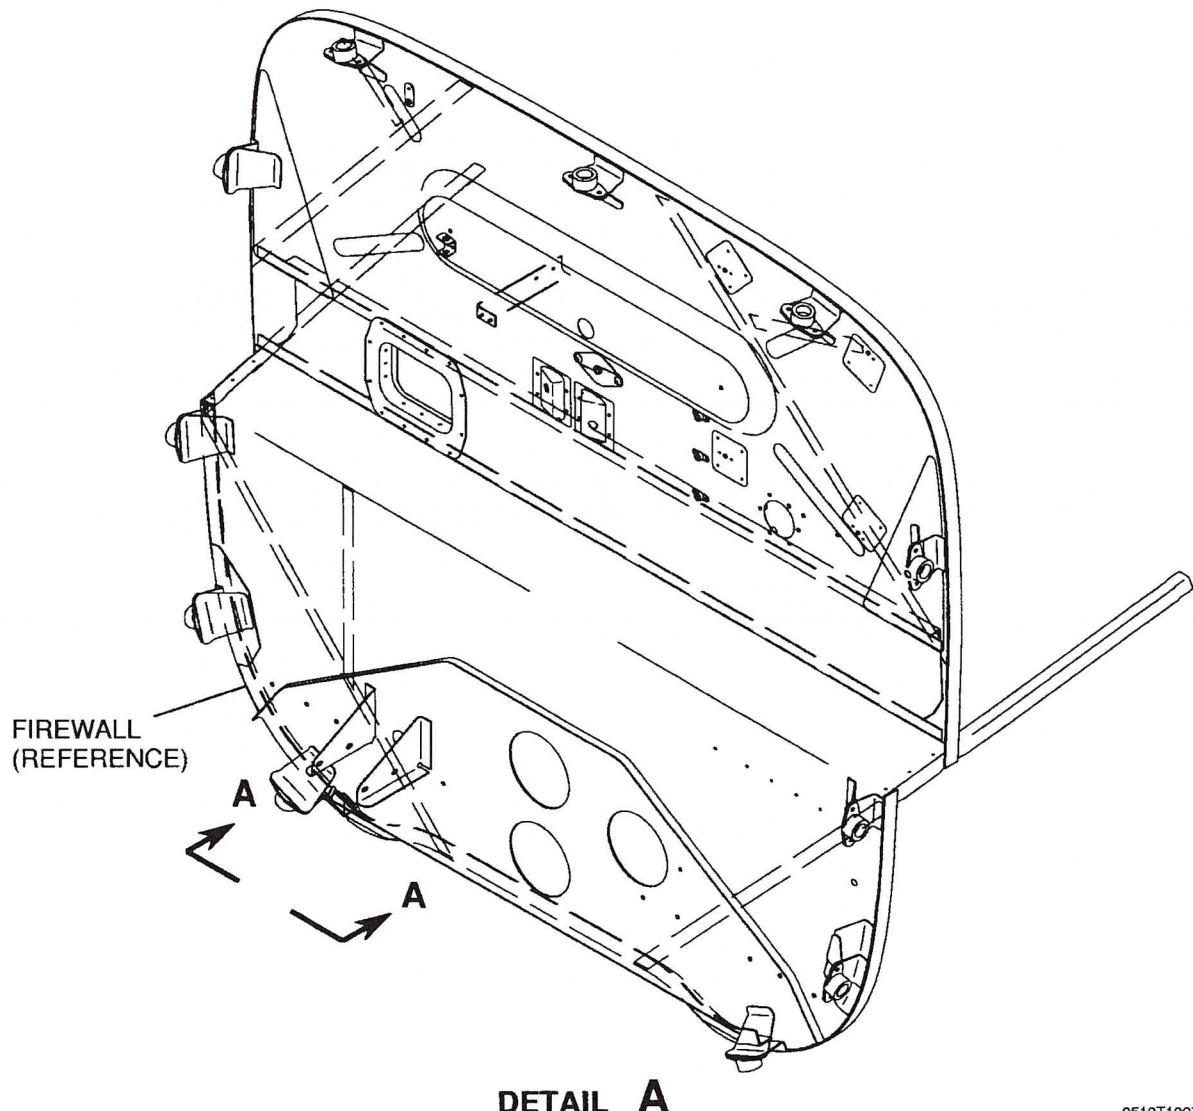
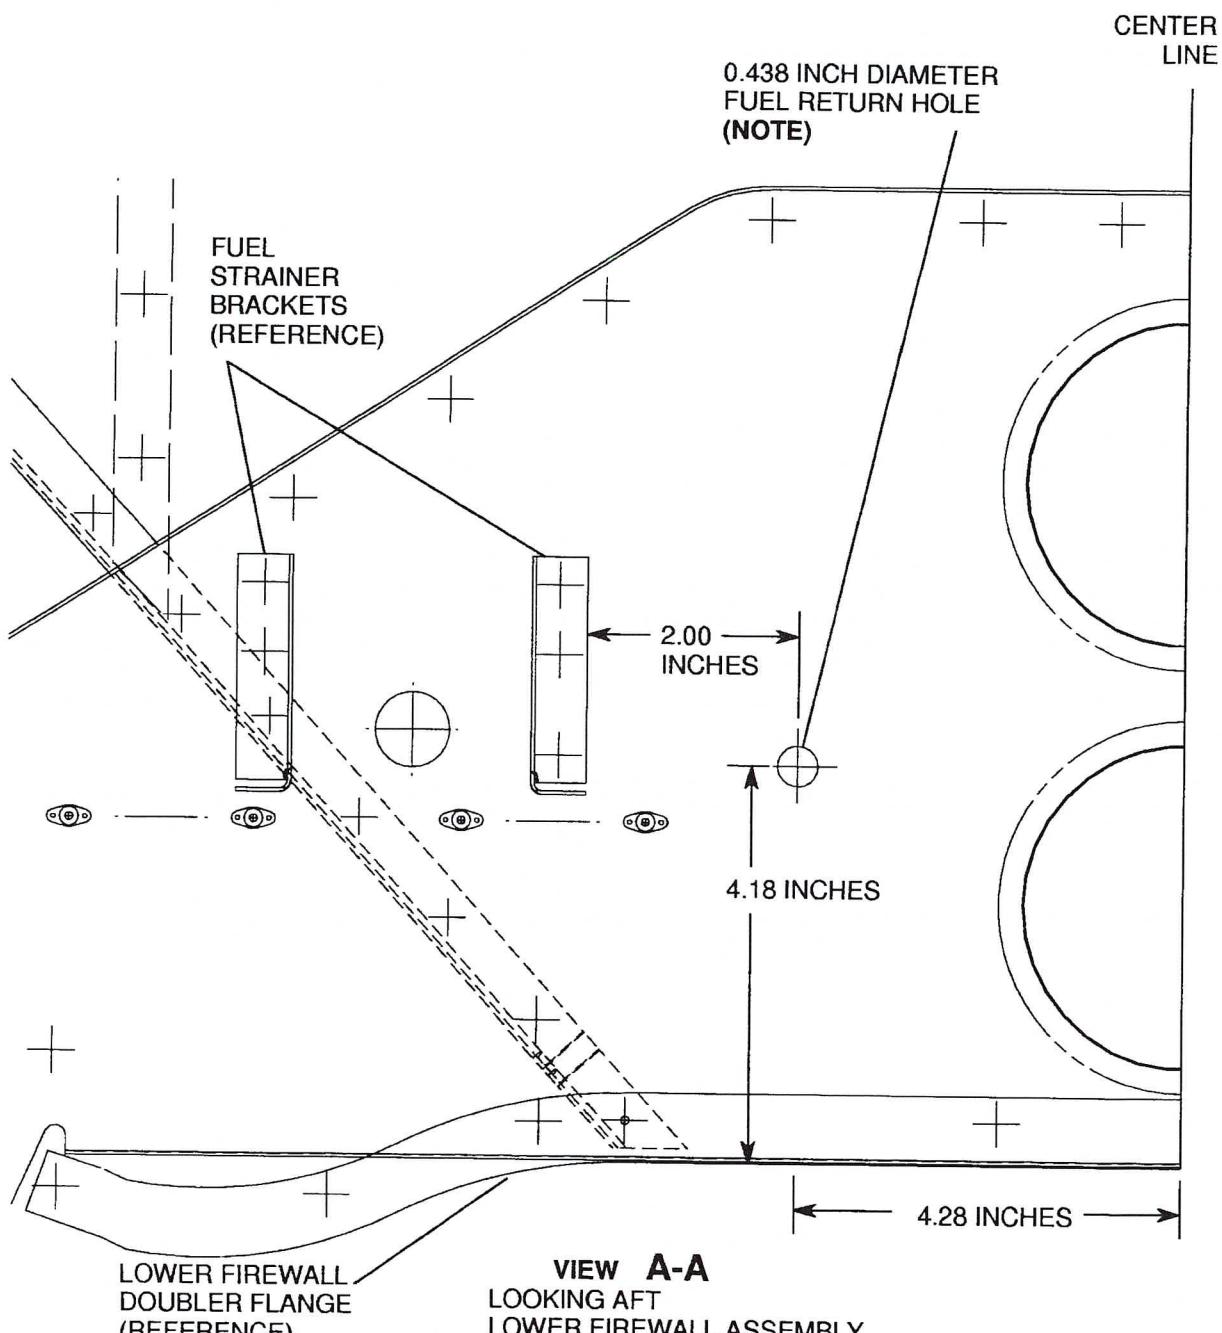
Figure 2. Fuel Return Firewall Hole Installation (Sheet 1)

**NOTE:** DRILL A 0.438 INCH DIAMETER HOLE IN THE LOCATION SHOWN AND MAKE SURE YOU DO NOT DRILL INTO ANY OBSTRUCTIONS OR STRUCTURE ON THE AFT SIDE OF FIREWALL.
